**REPORT ON MATERIALS  
CONTAINED  
IN THE HULL OF THE FORMER  
CLEMENCEAU**

**VOLUME 1  
FINAL REPORT**

This document constitutes the survey report on potentially hazardous materials contained in hull Q790.

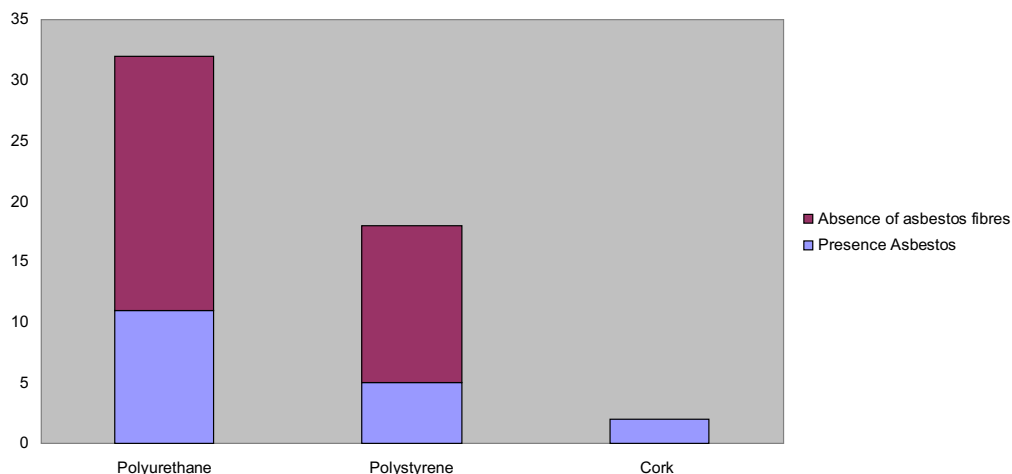
The graph below details, by sample number, and for the different supports, the result of the analyses for presence or absence of asbestos.

For the 52 samples, the three insulating materials are found (polyurethane (32 items), polystyrene (18) and cork (2)) and with the presence of asbestos fibres ascertained for the samples with polyurethane (11 cases), polystyrene (13) and cork (0), i.e. a total of 18 cases (35%).

Neither the documentary analysis of the system or of the plan positions of the rooms crossed, nor the results of the laboratory analyses enable linking of the nature of the insulating material to the asbestos or non-asbestos state of the cloth.

**Rec 18.:** It is recommended that all chilled water systems be considered to contain asbestos.

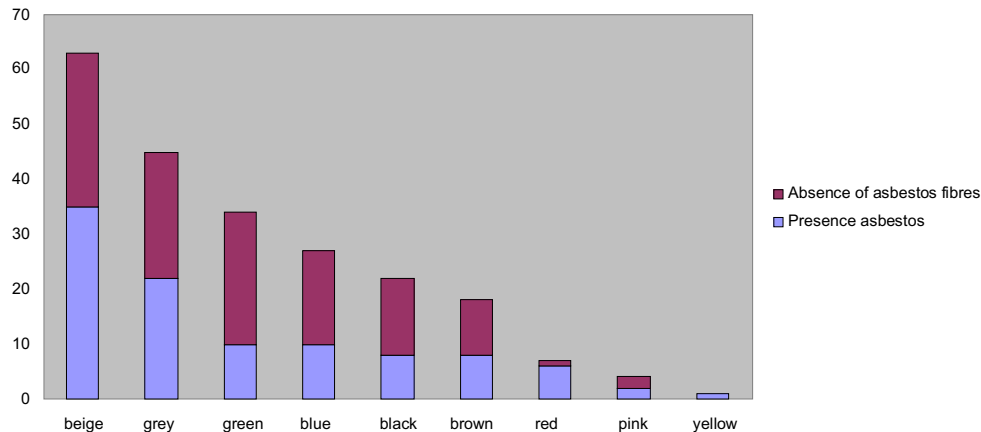
The graph below details, by sample number, and for the different colours identified by the laboratory, the presence or the absence of asbestos in the floor slabs. The samples were taken throughout the ship.

It appears that nearly 50 % of the analyses results indicate samples containing asbestos but with no link to a plan position.

It should also be noted that from all the samples including glue, about ten glue elements contain asbestos.

**Rec 23.:** It is recommended that all floor slabs and glue be considered to contain asbestos.

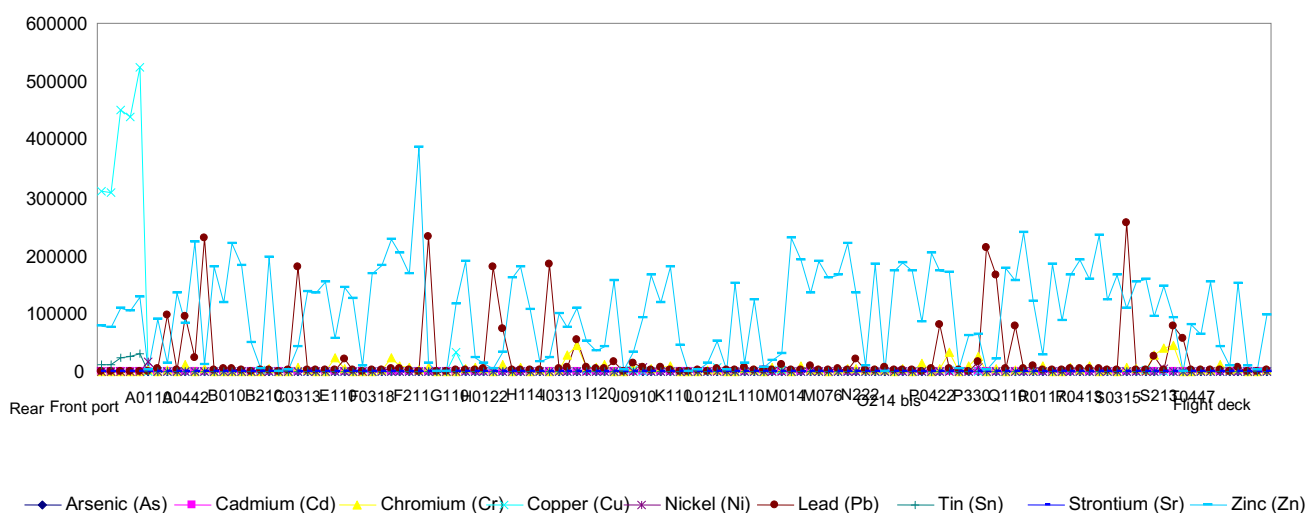
#### All heavy metals included

The graph representing the different elements highlights the importance of some concentration peaks, particularly for lead and chromium.

The graph also shows a “background noise” for the other concentrations.

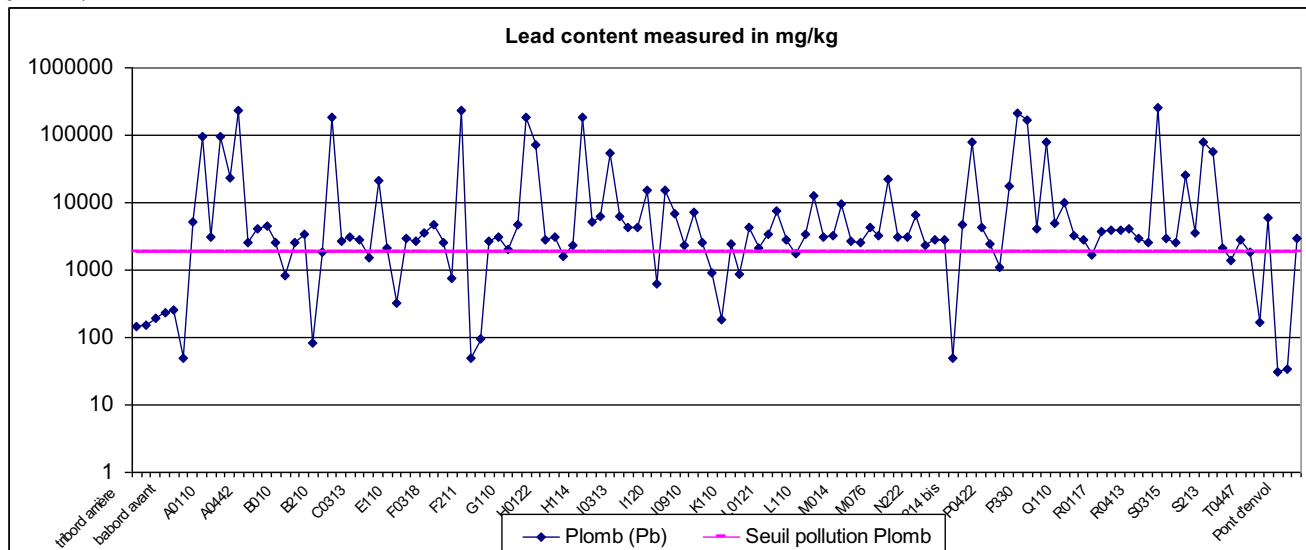
The graph (on a logarithmic scale) below represents the analyses results by room. The value of 1800 mg/kg is indicated by way of comparison (regulation pollution threshold for ships, see §6.1.2).

- In spite of the distribution differences of the rooms between the 1956 painting plan (design plan) and Q790, 23 % of the rooms initially to be painted with lead paint still present lead pollution.
- Among the walls surveyed, 5 proved to be polluted by lead whereas the paint plan did not envisage that (walls chosen "at random").
- Some interior and exterior walls of the block are polluted by lead; the block is not described in the painting plan.
- Some "aberrant" measurements undoubtedly correspond to paint repairs carried out during the life of the vessel. Those repairs are not visually detectable.
- The samples taken from the hull and on the flight deck do not contain any lead.

**Rec 31.:** It is recommended that internal paintwork be considered overall to be polluted by lead, as well as paintwork external to the block.

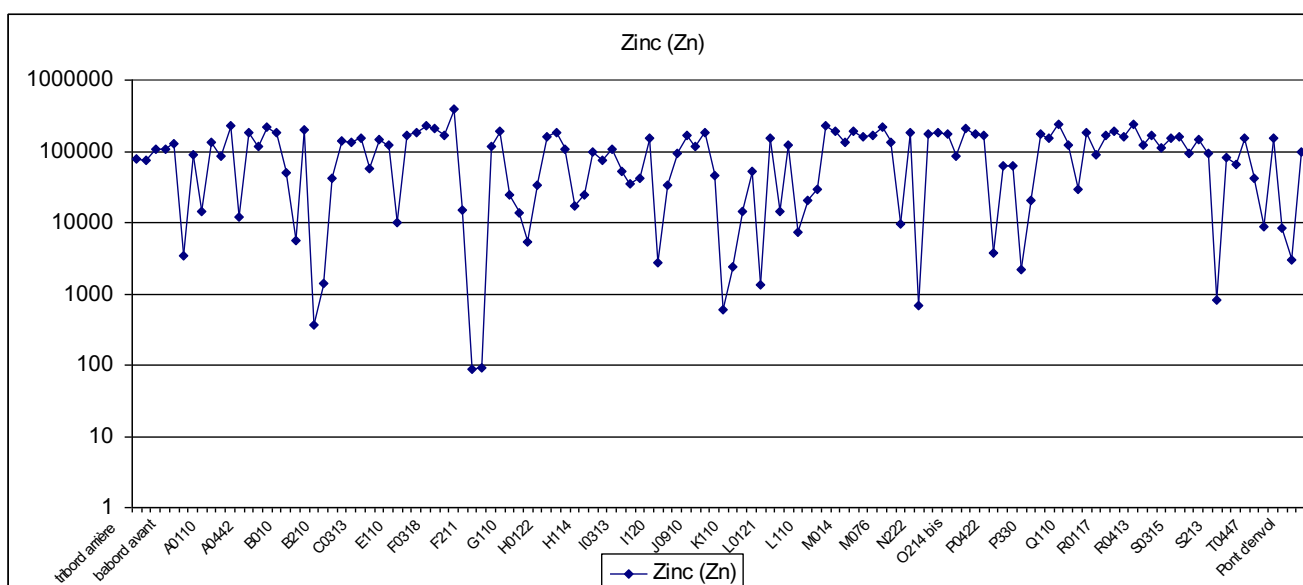
The graph (on logarithmic scale) represents the results of analyses by room.

An average concentration appears, evolving between 10,000 and 150,000 mg/kg.

Bearing in mind the concentrations observed in the analyses, it will be necessary to protect personnel working on the dismantling against paint dust and to guarantee against "natural" or involuntary discharges into the environment.

**Rec 33.:** It is recommended that all paintwork be considered to contain zinc.

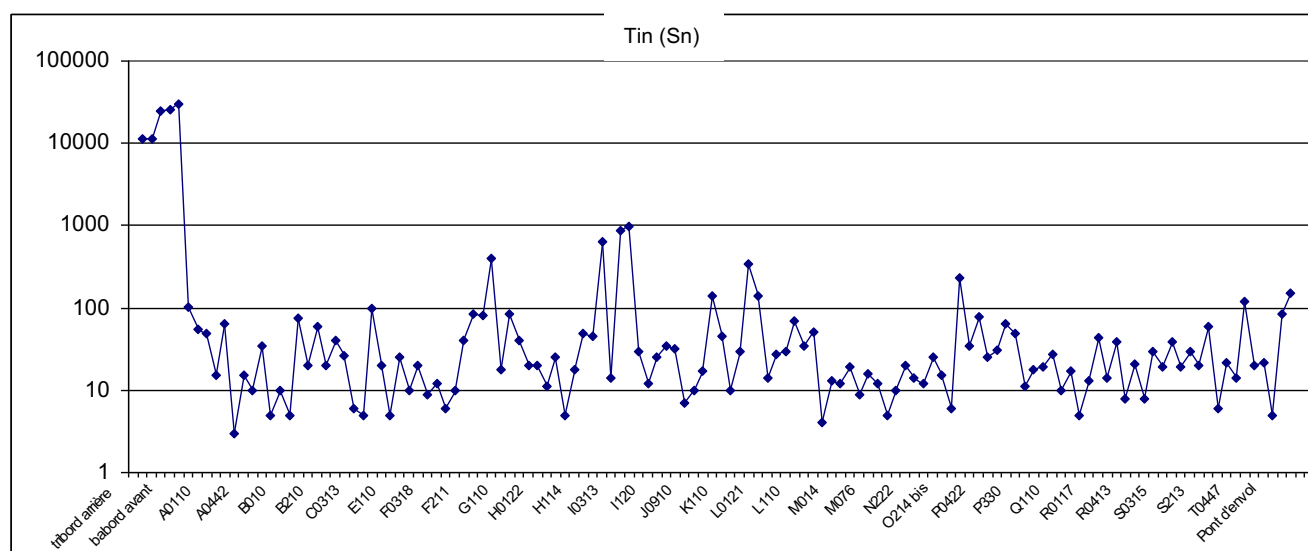
For other surfaces, the graph (on a logarithmic scale) represents the results of analyses by room.

With the exception of the hull, the maximum value observed is less than 1000 ppm with an average value of 60 ppm.

**Rec 34.:** It is recommended that monitoring of the impact of the hull on the quality of water be maintained.

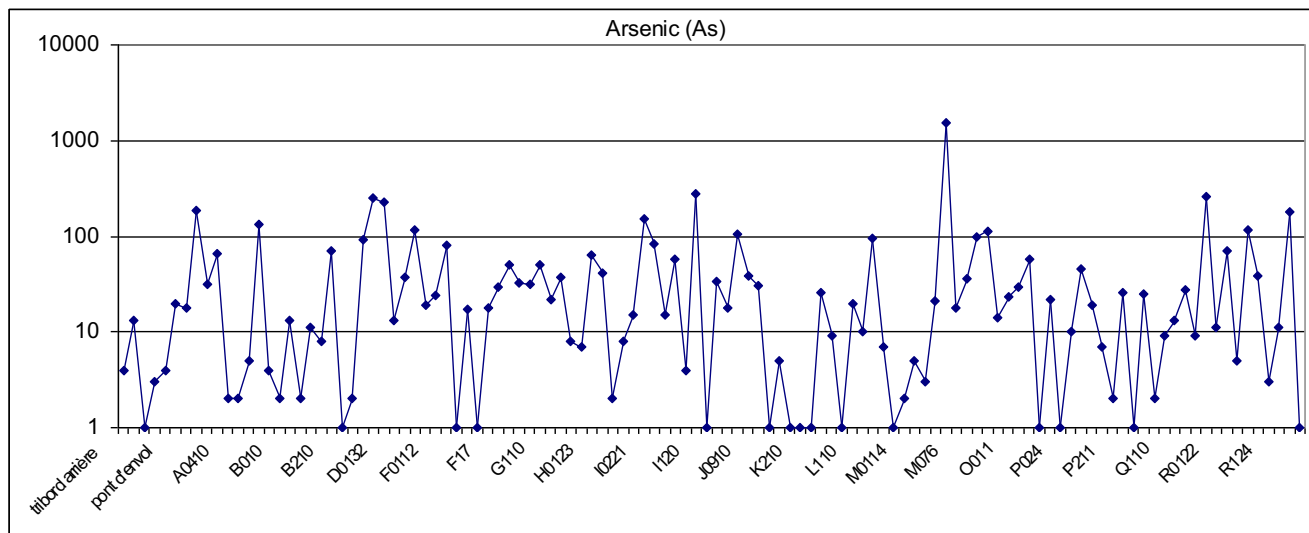
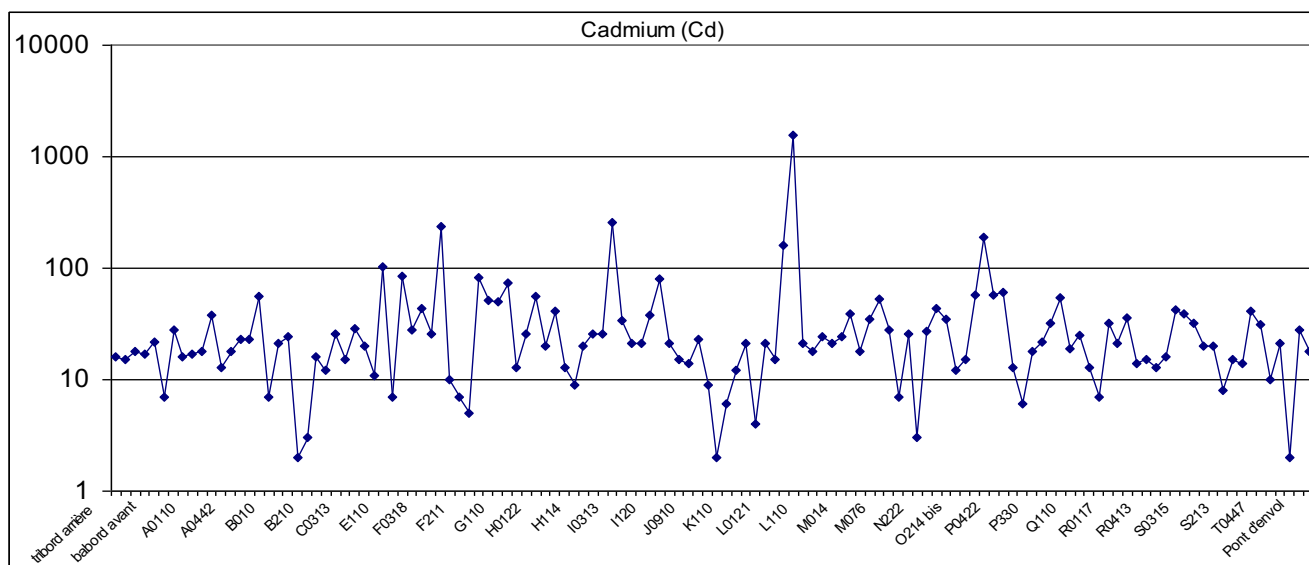
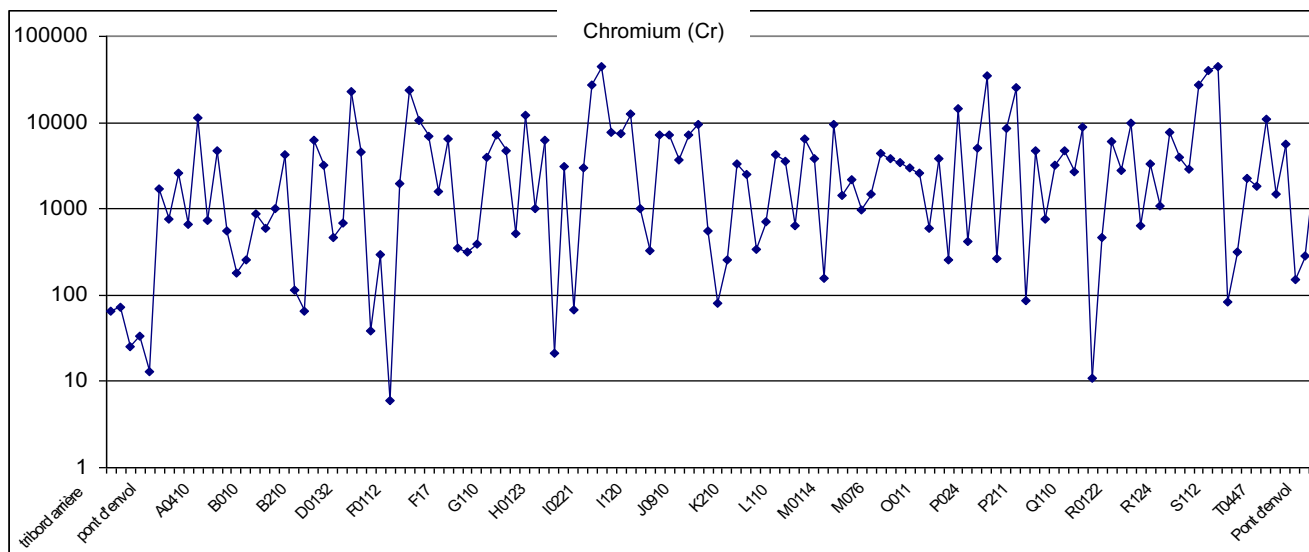
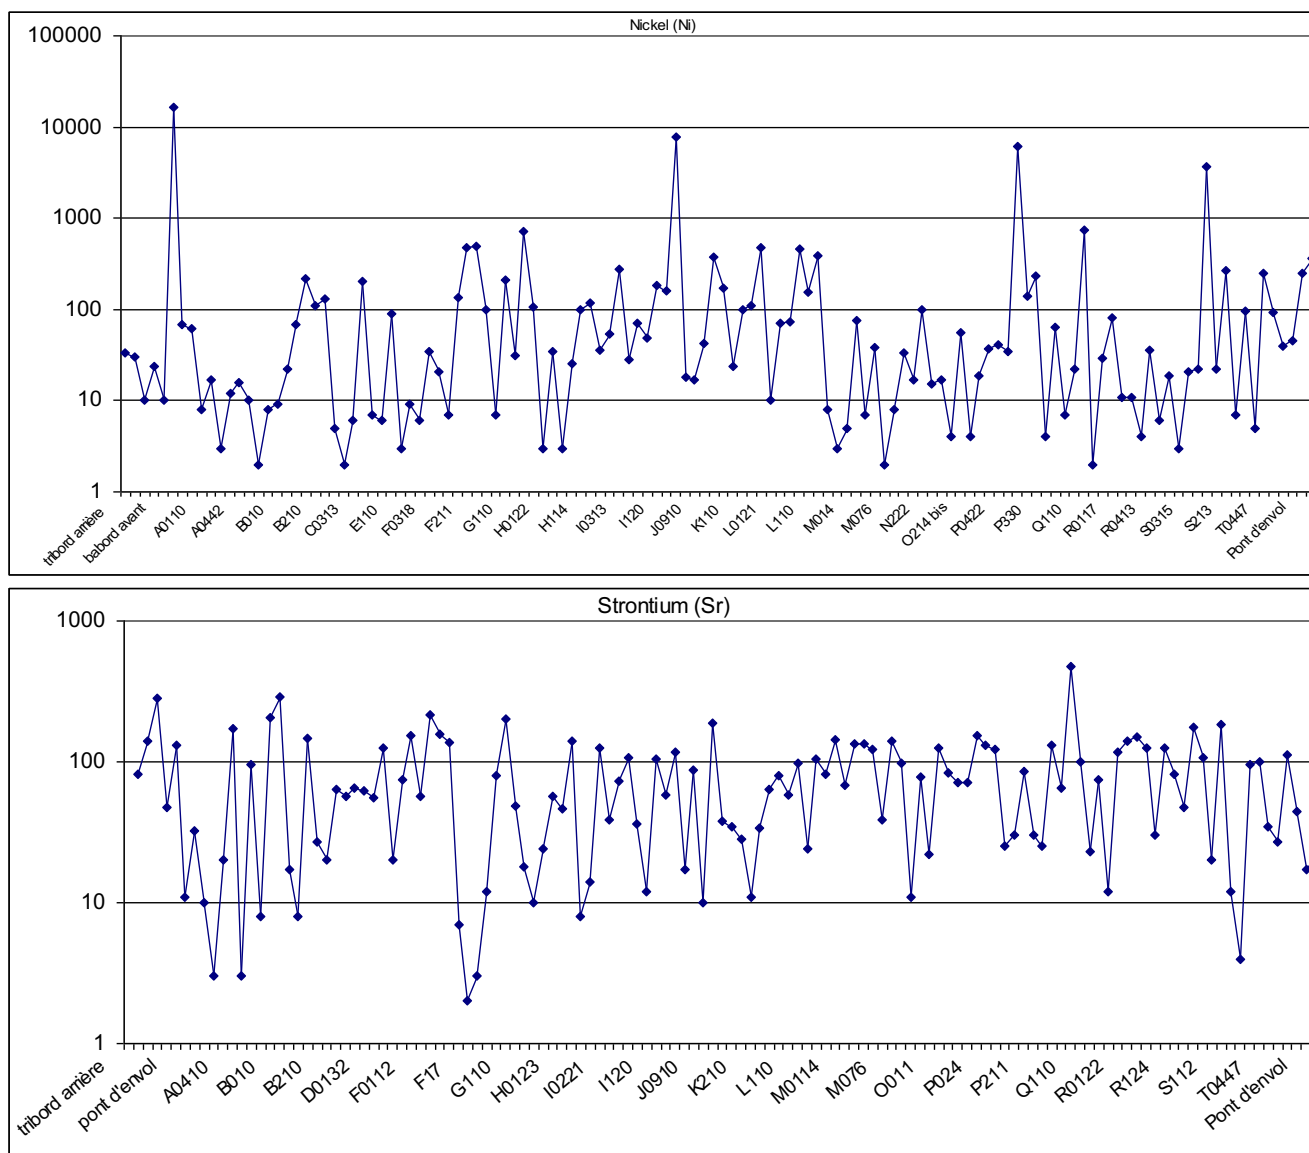
The graphs (on a logarithmic scale) represent the results of analyses by room for the different elements considered.

The toxicological records of these five heavy metals indicate a danger on ingestion or even inhalation, a danger for the environment and, for some, high toxicity for the marine environment.

**Rec 35.:** It is recommended that aerial discharges (dust) or discharges in solution be limited for all paints.

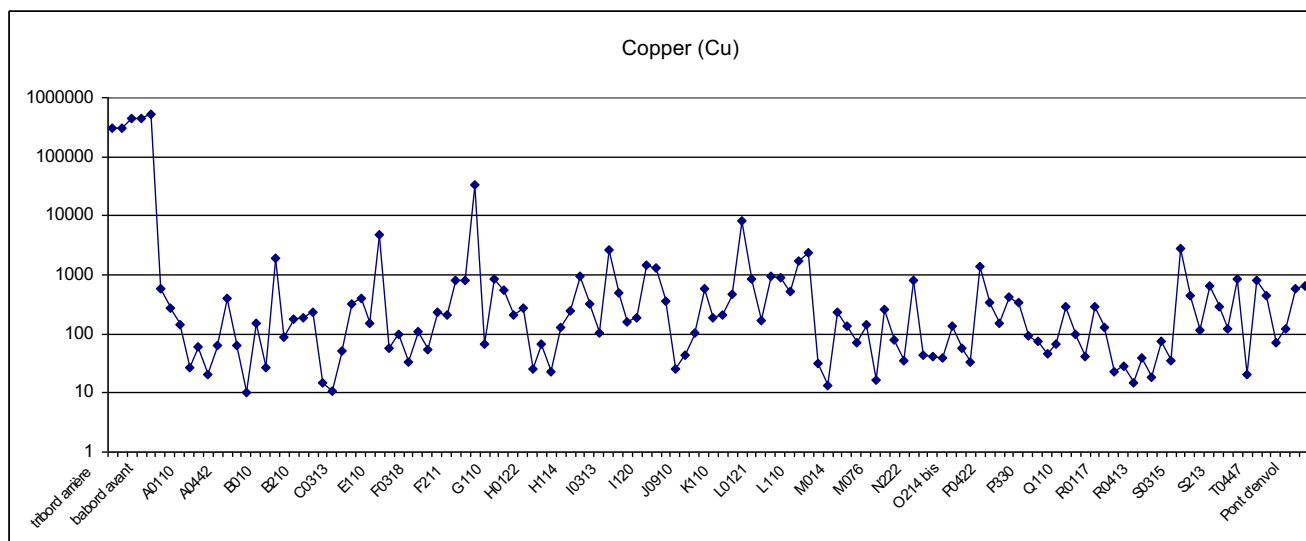
The graph (on a logarithmic scale) represents the results of the analyses by room.

However the high concentration observed in the immersed hull samples must be noted. The state of the hull paintwork (see photos) is dealt with in the impact report.

**Rec 36.:** It is recommended that the evolution of the hull paintwork be monitored.

**Rec 37.:** It is recommended that monitoring of the impact of the hull on the quality of water be maintained.

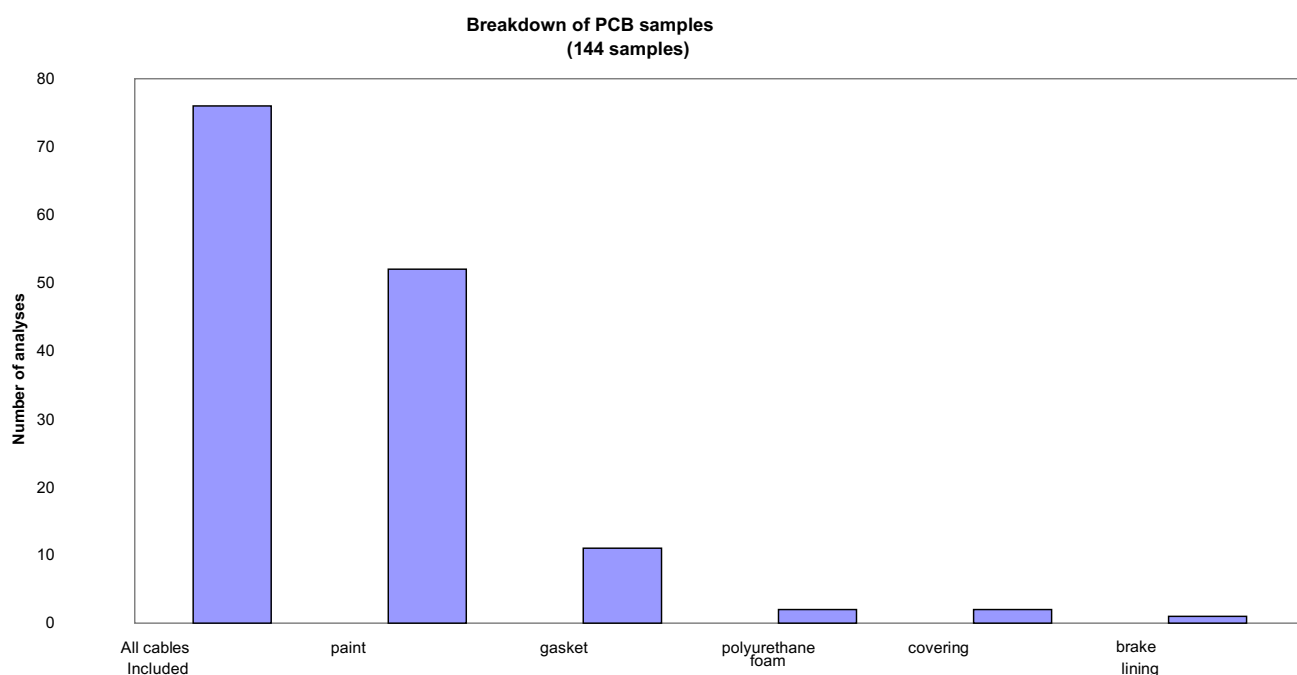
The graph below summarises the different types of materials analysed.

- Electric cables in large quantities and presenting high heterogeneity account for half of the samples, namely 76 samples;
- Paints also presenting high heterogeneity account for nearly a third of the samples (52 items) with particular attention to the plant rooms associated with electricity;
- Gaskets being strongly typified, one or two samples were done per type of gasket;
- Polyurethane foam being homogeneous, two different samples were carried out;
- Linoleum flooring and the pipe lagging polyurethane being homogeneous, two different samplings were carried out;
- Brake linings being in small numbers and homogeneous, only one sampling was carried out.

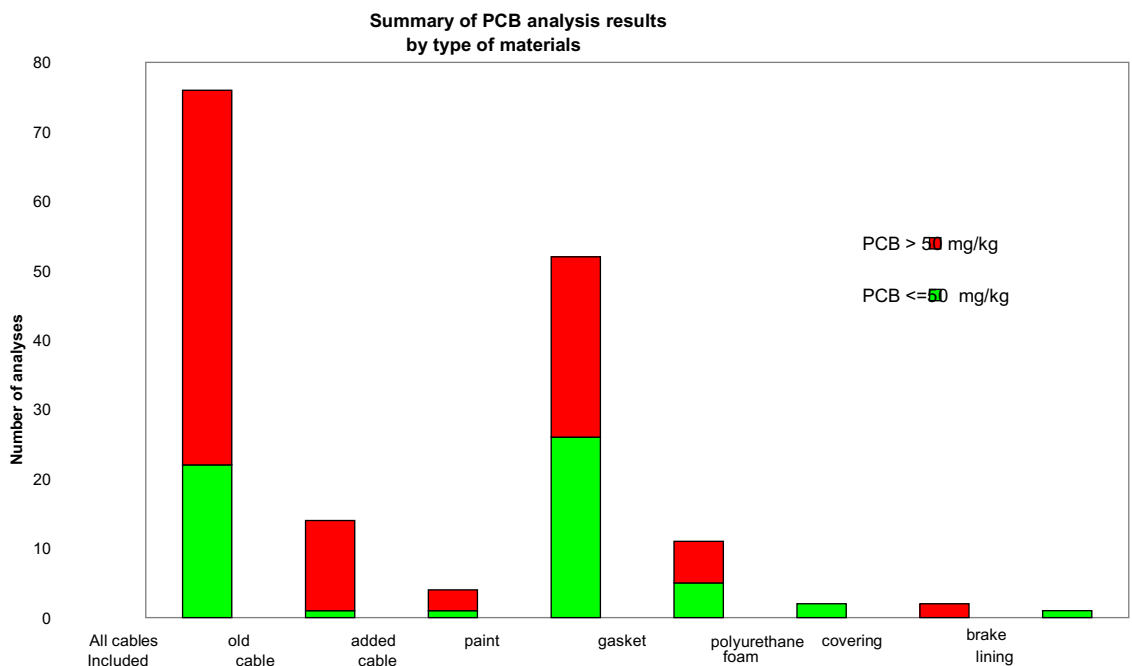
The graph below summarises the distribution by type of materials from the analyses results.

71% of the samples of cables analysed (out of 76 available) and 50% of the paint samples analysed (out of the 52 available) show a content greater than 50 mg/kg.

Moreover, when the information is available, the cables were able to be split between old cables (fitted in the ship's trial period) and added cables (installed with the addition of equipment): samples of old cables are almost all polluted (93%) and more than 70% of the samples of added cables are as well.

Rec 39.: It is recommended that the electric cables be considered to be polluted by PCBs. Specific precautions are to be taken concerning cutting and handling (possible presence of asbestos, a generic problem with cables of the time).
